MOHAWK RIVER BASIN
BATAVIA KILL WATERSHED PROJECT
DAM No. 1

I.D. No. NY-615
PHASE I INSPECTION REPORT

Name of Dam: Batavia Kill Watershed Project Dam No. 1
I.D. No. NY-615 (#191c-3901)

Date of Inspection: July 11, 1978

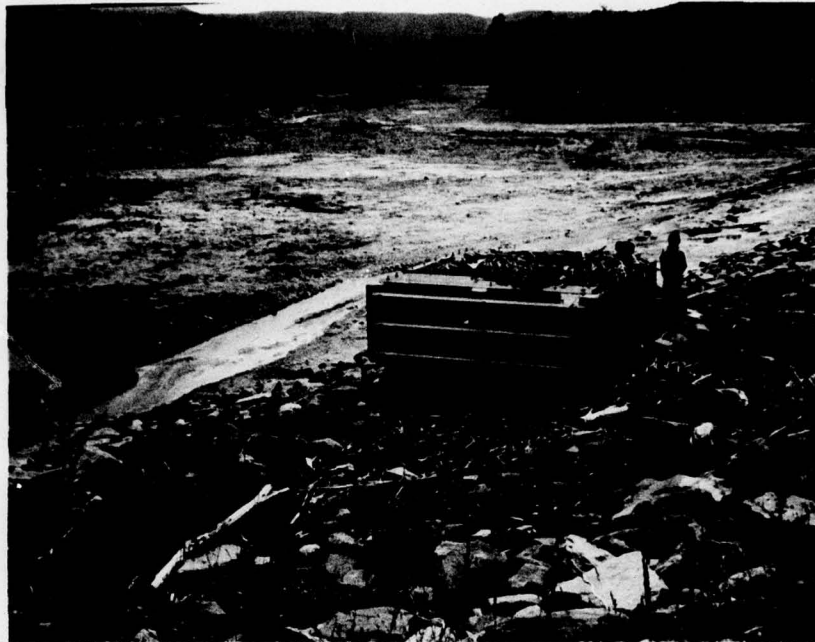
1. Hairline cracks in the concrete were evident at the inside corner of the intersection of the vertical drop inlet and the crown of the concrete pressure pipe.
2. Joint separations of less than 0.75 inches at the first two pipe sections downstream of the drop inlet base.

INLET OF PRINCIPAL SPILLWAY
@ RISER

b. Structural Cracking HAIRLINE CRACKS @ INTERSECTION OF RISER &
42" PIPE CROWN

- a. Periodic operation and lubrication of the mechanically-operated slide gate mechanism to insure a continued ease of operation of the reservoir drain conduit.
- b. Monitoring of the principal spillway hairline cracks in the concrete at the intersection of the vertical drop inlet and crown of the concrete pressure pipe. This monitoring is to insure that any future crack development, if it occurs, may be discovered prior to the need for major corrective action.
- c. Periodic inspections of the principal spillway concrete pressure pipe joint separations to determine if additional separation is occurring.

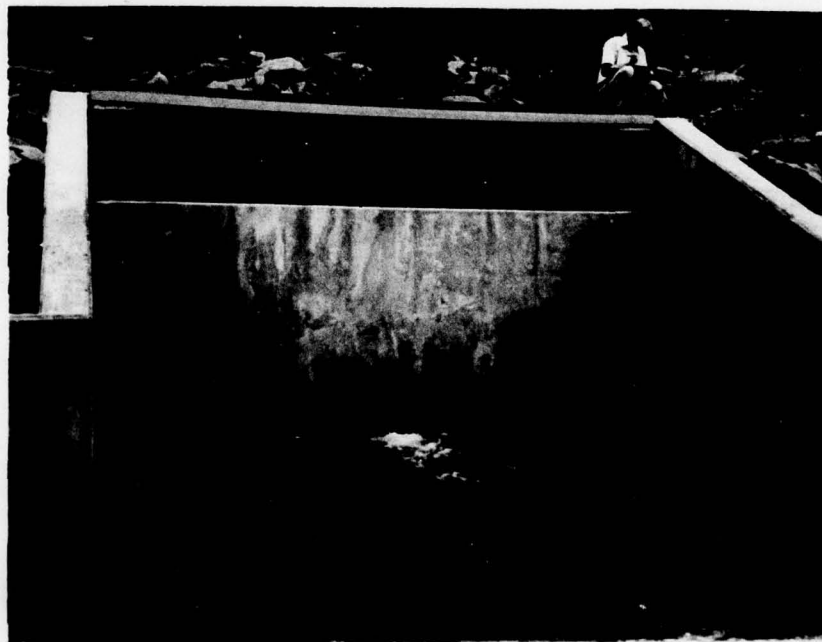
The principal spillway consists of the vertical drop inlet structure, a concrete pressure pipe through the embankment, an impact basin, and an outlet channel. All of these components were in satisfactory condition except for the following minor deficiencies:

OUTLET OF PRINCIPAL SPILLWAY
@ IMPACT BASIN
